S-112
Old Barnes Farmhouse
Princess Anne vicinity
private

c. 1820, c. 1850, c. 1900

**Maryland Historical Trust
State Historic Sites Inventory Form**

Survey No. S-112

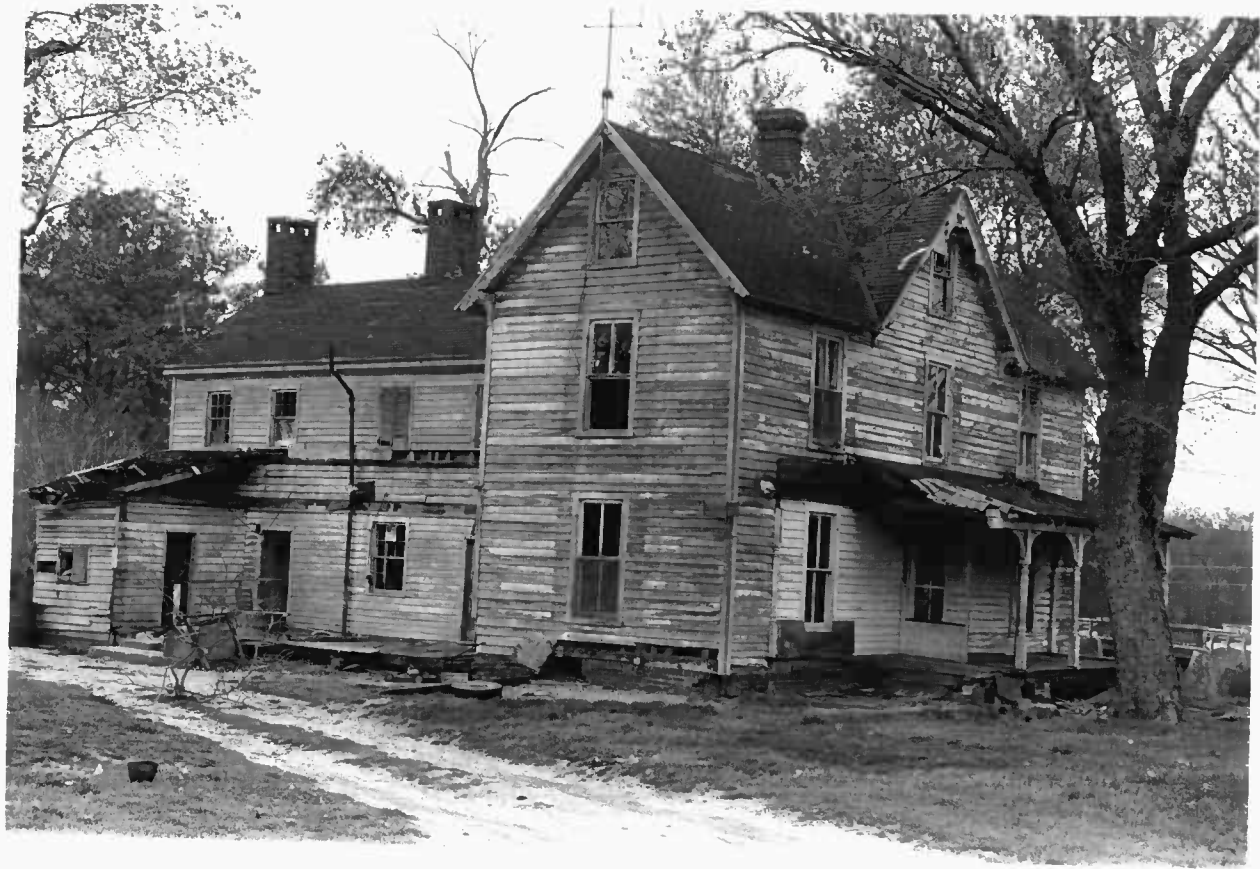
Old Ben Barnes House S-112
Princess Anne Vicinity, Somerset County
Northeast Elevation
4/85, Paul Touart, Photographer
Neg/ Md. Historical Trust

The northeast (main) facade is a symmetrical three-bay elevation with a center double door and flanking two over two sash to each side. The double doors are glazed above the lock rail and paneled below. A three-bay porch stretches across the first floor and is supported by turned porch posts with sawn eave brackets. The second floor is marked by three two over two sash windows, while the center cross-gable is pierced by a multi-pane sash window. The upper eave is decorated with sawnwork, and the principal corners of the roof have simple C-shaped brackets.

A pair of brick chimneys rise from the center of the main block and flank the hall. Each chimney is finished with a corbelled cap. Most of the Federal period exterior finish has been removed from the principal facade except for one diamond cross-sectioned foundation grill that is located under the front porch. Some of the siding has been removed which exposes the mortise and tenon framing of the early house.

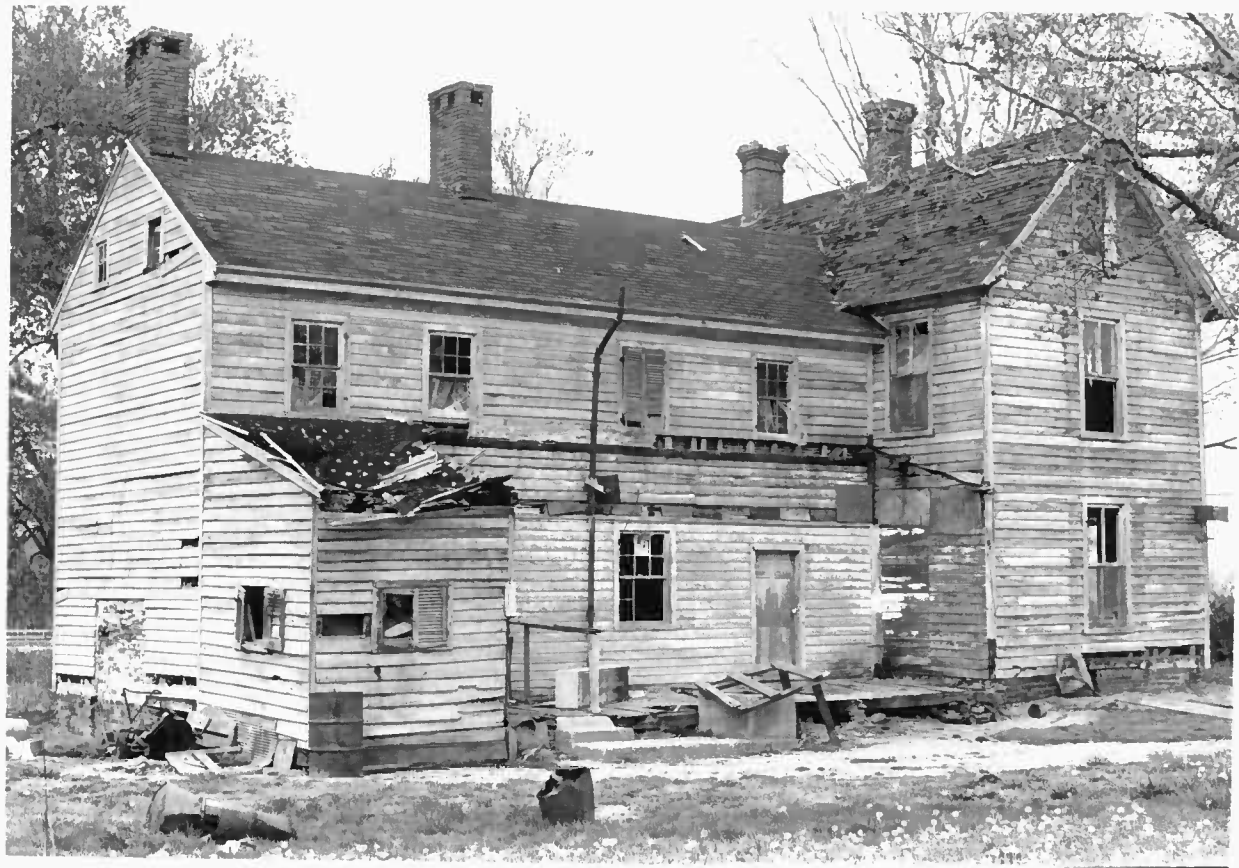
East Elevation

The northwest and southeast gable ends are essentially alike with a single two over two sash window on each floor and a multi-pane sash window in the upper gable. Evident on the southeast end is the patched foundation wall where the interior and chimney was formerly located. Under the house is the pair of headers that framed the hearth.
